## Control Strategies for Minimizing Speed Variability Due to Lower Extraction Steam Flow

### ABSTRACT

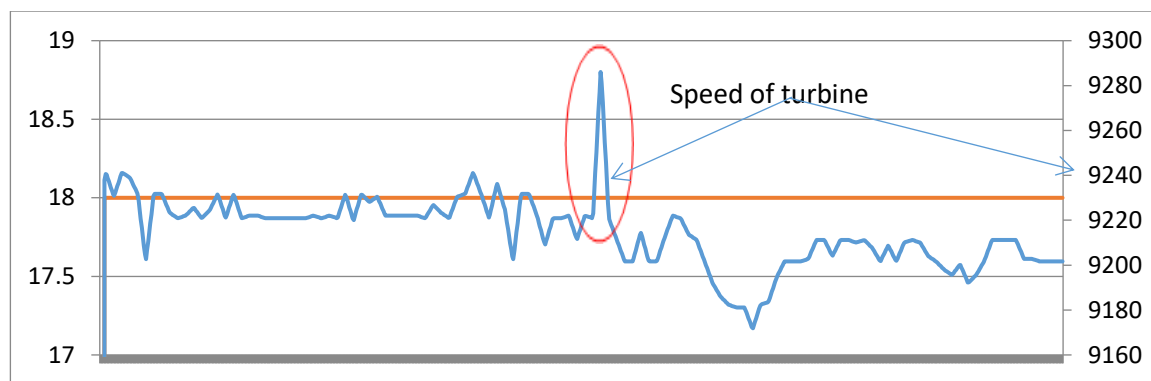
As shown in graph speed (Blue line) have taken sudden jump in graph, change in speed is around 80 RPM as per graph but in real it is of 200RPM (due to average value of 4 second it is less in graph). While no change in speed command given to governor by any signal. This new type of problem is faced in extraction cum condensing turbine. On 17th nov17 plant is also forced to trip on the same condition, we observe that turbine speed suddenly came down to 1000 rpm and turbine could not retain the speed again data is as per below detail

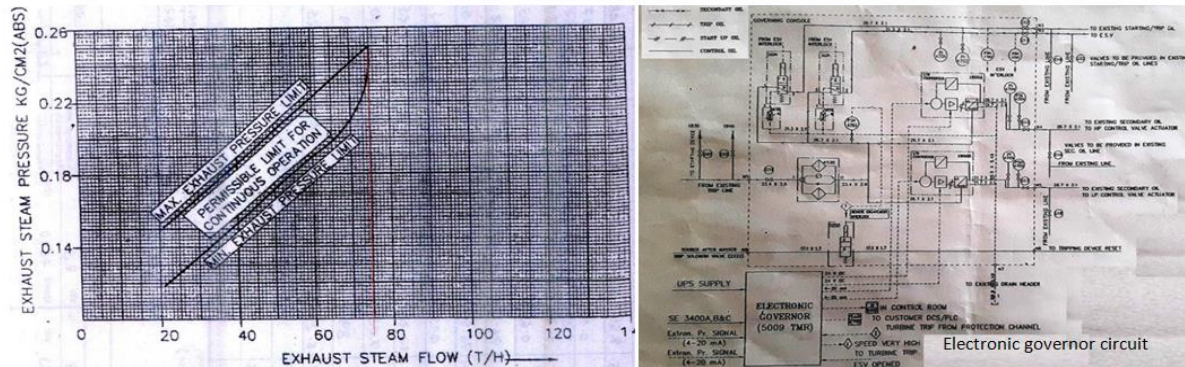
From above table we find that in past, turbine was run at more condensing load (72T/H) but at present above 66T/H flow of condensing steam turbine starts hunting of approx 100-200RPM. So we again check maximum design

condensing flow by below curve(supplied by Manufacturer), which clearly states that we can go up to 75ton condensing load.

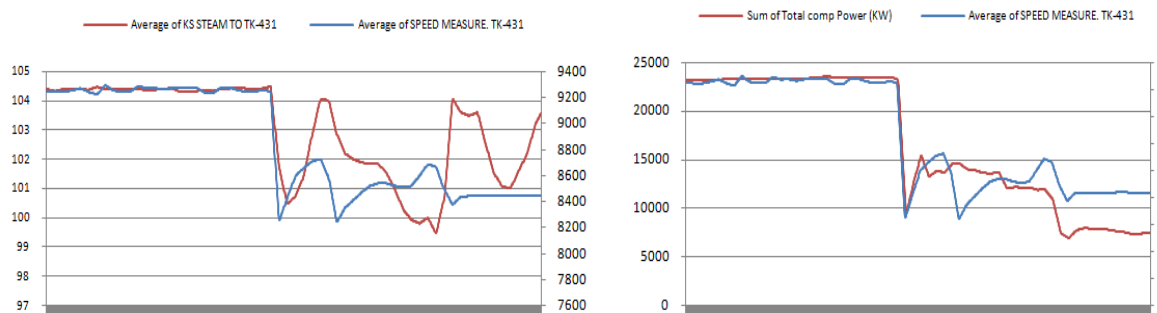
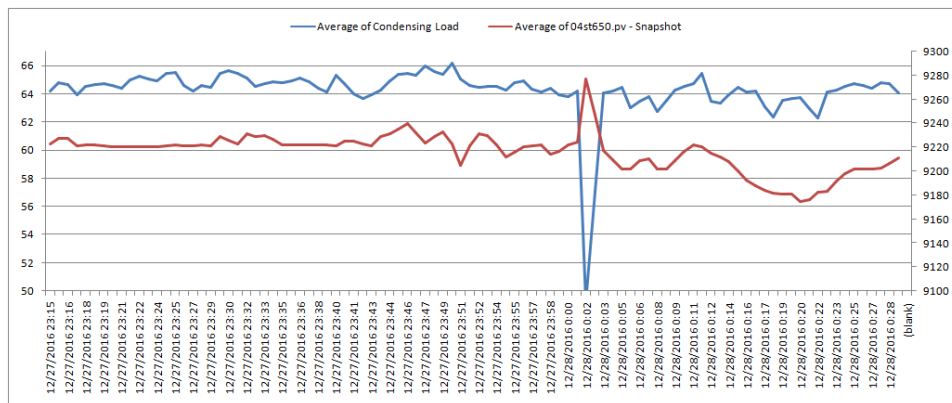
### Current running graphs

It is clearly visible from above and below curve that after a certain condensing load this phenomenon occurs. In this case when we tried to increase the condensing load above 66T/H the speed fluctuation appeared and LP control vane started oscillating .

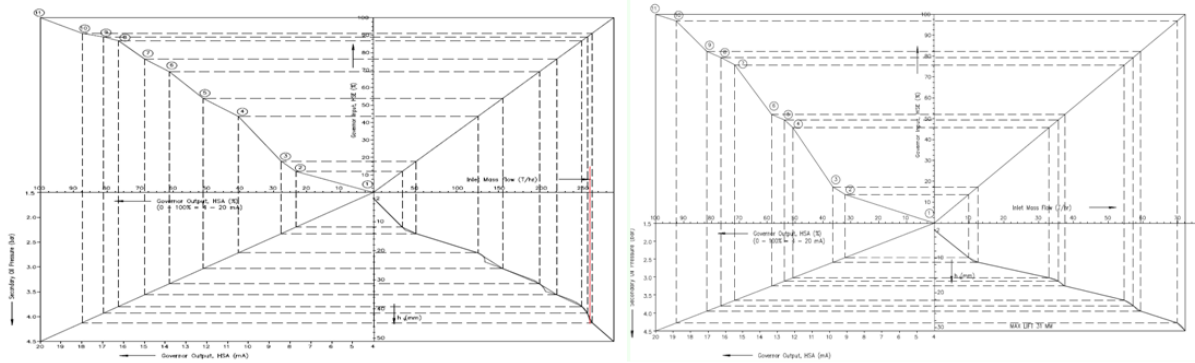
From exhaust curve we noticed that turbine was below design limit and also from HP & LP valve characteristic curve we notice that turbine governor is map up to 75T/h exhaust load.

From above we also notice that all the parameters are within range. Power of turbine and speed are directly link so we go through power calculation of turbine, Turbine is divided in to two part HP and LP from both the section power is generated. In HP section power is generated by KS steam and in LP section power is developed by HS(42kg/cm<sup>2</sup>) steam. Power ratio developed by steam in both the section \*KS steam-105kg/cm<sup>2</sup> at 550°C & HS steam-41kg/cm<sup>2</sup> at 350°C

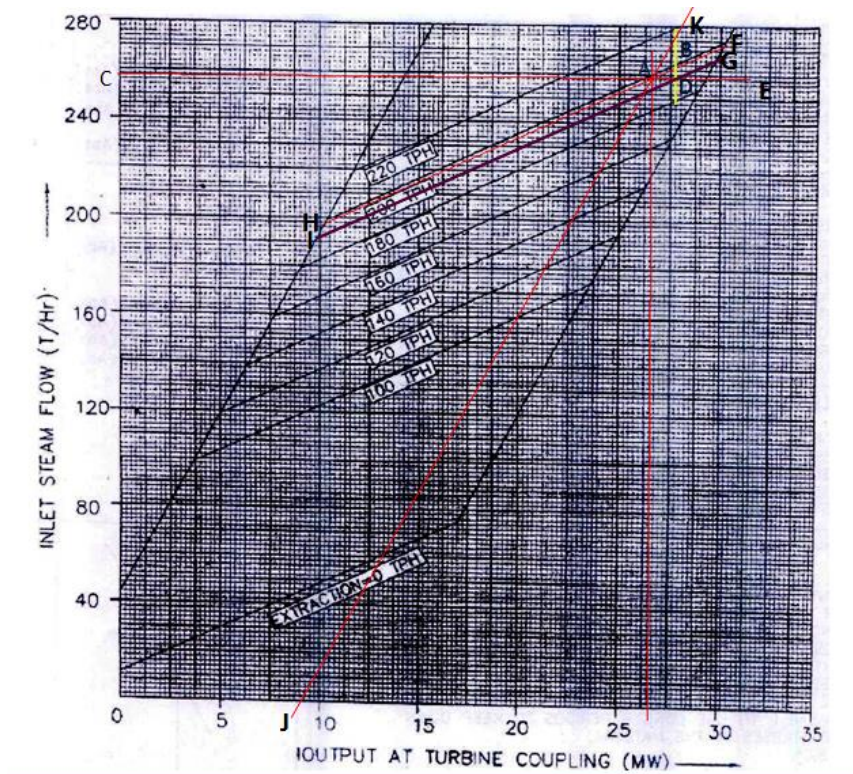
But problem is why speed hunting in decreasing the extraction steam flow, for identifying the problem we go through below steam flow Vs power curve (supplied by OEM ) and draw following

Line CE- Current KS steam inlet flow

Line HF-Current extraction flow

Line IG-Extraction flow required

Point A- current operating point

Point D-Desired operating point

Restriction in condensing flow= 6 T/H (72(designed/ previously achieved)-66(existing max flow))

Reduction in power= $\eta Q \cdot h = 0.6 \cdot 6000 / 3600 \cdot 3157.52 \text{ KJ/kg} = 3157 \text{ KJ/s} = 3.1 \text{ MW}$  (taking turbine LP stage efficiency 60%)

Drawing line JK for this flow reduction of 3MW which is passing from point A so if we crass point A, power will not developed by turbine and governor will not take action as per current condition first it will reduce the extraction steam but due to not developing of power by LP section, speed will drop and so it will increase KS flow for maintaining the speed but since the extraction steam is restricting by command and condensing path chocking governor was starting malfunctioning and results in speed hunting.
