## Impact of Overloading Conditions on Servo System Vibrations in Steam Turbines

### ABSTRACT

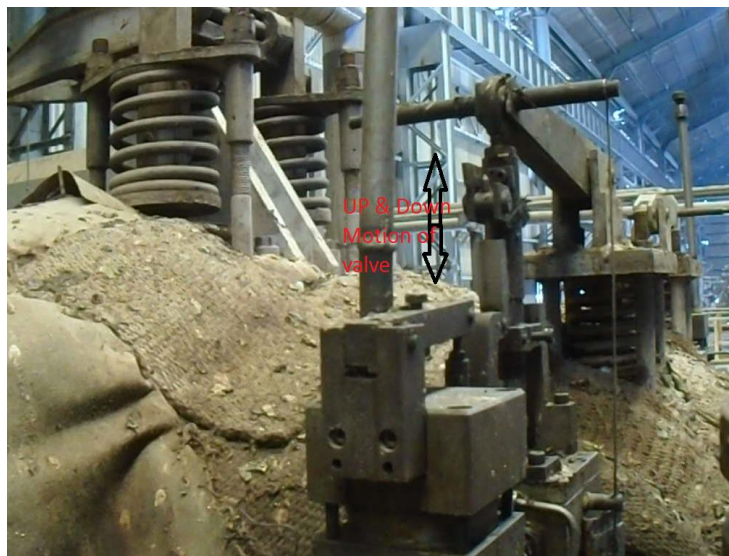
It is a pic of condensing come extraction type turbine, in which HP and LP valve is shown. Hp valve is for high pressure enters in the turbine and LP vale for the medium pressure entering in the second section of the turbine. Small up and down motion of the spindle is a normal phenomenon of the governing system but almost all turbines faced problem of high magnitude of up and down motion of spindle and causing speed fluctuation in the turbine. Certainly it is a known problem to the all plant operation people. It may be due to air locking in the governor or locking of rotation of the servomotor spindle (part no 17 of the servo motor) but very high vibration of servomotor and hydraulic is the new problem in the system which is generally faced after overloading of the turbine.
